**RECLAMATION PLAN FOR EXPLORATION PROJECT E23/00/033
(Eureka/Sunbeam/West Mammoth) AND SMALL MINING
OPERATION S23/00/041 (Mammoth Mine)**

Submitted July 14, 2000 by Spenst Hansen (an individual), Keystone Surveys, Inc., West Tintic Mining Company, and South Iron Blossom Mining Company.

A. Exploration Project – E/023/033 (Eureka/Sunbeam/West Mammoth).

B. Mammoth Mine Project – S/023/041

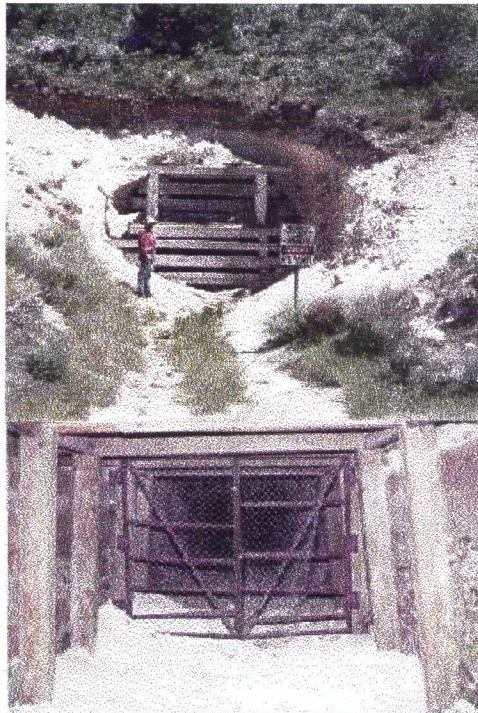
No mining of any kind has been carried out. Only a very small quantity of broken rock and rotted mine timbers have been removed from underground. Sage and wild grasses are growing around the portal and with the exception of a small area to the right of the portal there is no evidence of mine wastes or dumps.

The below two photos show the interior steel gate and the surface portal closure with mine timbers.

Top photo: Centennial Eureka Holden Tunnel showing the surface closure and vegetation.

Bottom photo: Interior steel gate. (202-6)

Recommendations for site reclamation include adding additional mine timbers to the portal to make certain unauthorized access cannot be gained by the public. Also, cleanup of the old mine timbers near the portal will be done, and reseeding of the small quantity of broken rock removed as a part of the retimbering work in 1988.

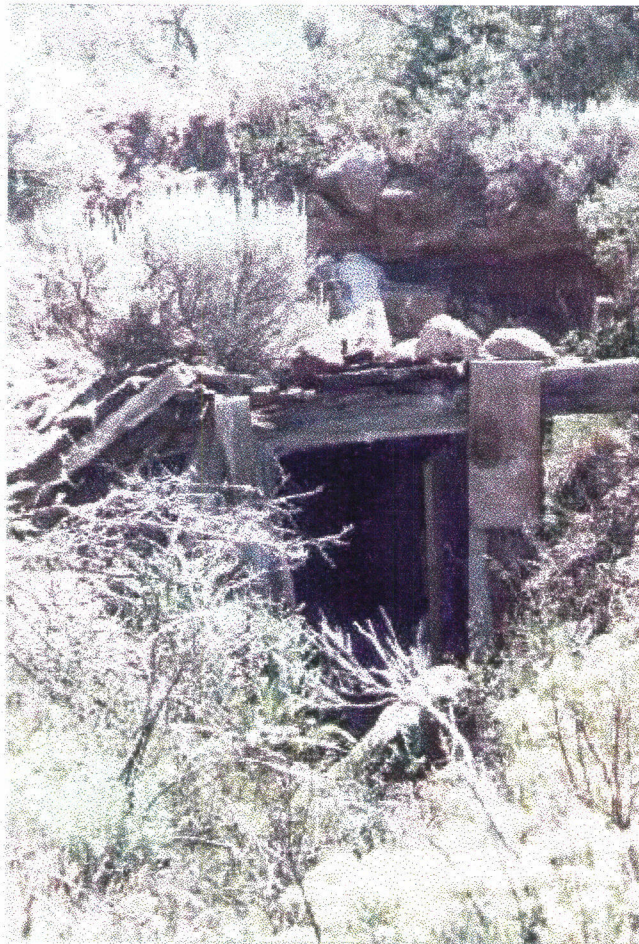
The Star tunnel is located 2000 ft. southwest from the Boss Tweed shaft (see map). The tunnel was driven southeasterly to the upper levels of the North Star mine. The tunnel is located approximately 500 ft. west from the North Star shaft. The portal is heavily vegetated with several natural species of trees, grasses and brush and has been reclaimed by nature. There appears to have been no mining or exploration activity here for a century or more. See attached photo. There are no obvious waste rock dumps in the vicinity of the tunnel. Archived records indicate that all mining operations at the Star mine ended previous to 1910. The entrance is supported by a wooden frame structure that is in poor condition due to rotting and lack of maintenance. The tunnel is driven into unconsolidated alluvium and is caved at approximately 50 ft. The portal area is experiencing moderate caving and sluffing. The tunnel portal measures 6 ft. x 6 ft. There has been no post 1974 law disturbances at this site. Recommendation for reclamation include the bolting of wooden timbers to the portal to deny access, although because the tunnel is caved within 50 feet of the portal, it does not constitute a danger to the public and should be considered low priority.

The star tunnel, this photo shows the mine entrance and the variation of vegetation growing around the opening. (203-17)

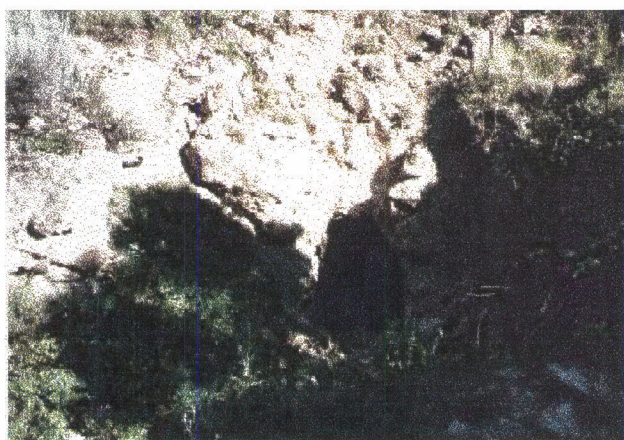
The Columbus tunnel is located at the western base of Treasure Hill, situated approximately 2 miles southeast of Silver City. The tunnel is driven easterly into competent rock, and shows very little caving. Old maps show it extends underground for over 1000 feet in an easterly direction. Because of its length and unknown underground condition, it might constitute a danger to the public. The entrance to the tunnel is in good condition with only a small amount of caving. The portal measures 6 ft. x 6 ft. The area is naturally vegetated with trees, grasses, and brush. A gated fence at the Silver Pass road currently restricts access to the Columbus Tunnel. No post 1974 law disturbances have occurred. Recommendation for reclamation

Columbus tunnel and various species of vegetation (204-3)

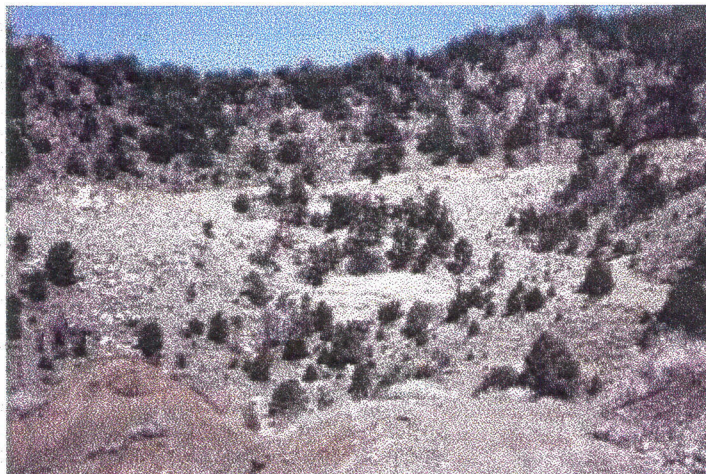
The Butterfly gap road is located about 1000 feet north from the Mammoth mine center and was initially constructed about 1993 by Centurion Mines Corporation to provide access to 6 drill sites for drilling exploration from the surface of the Butterfly breccia pipe area which was accessed underground from both the Grand Central and Mammoth Mines. This is one of the most promising untested ore drill targets known in the entire Tintic Mining District. This area has a long history of legal disputes as to its ownership. This road was initially constructed at considerable expense to provide for access to 6 drill pads to permit the testing of this highly prospective potential ore target. Unfortunately Centurion Mines Corporation was unable to finance the high cost of exploratory drilling. The road is also used for access to the water tanks that supply running water to the Mammoth Mine Center, and for residential purposes in the upper Mammoth area. The road disturbance is approximately 2.1 acres.

The Butterfly gap road. (199-1)

Suggestions regarding reclamation and remediation—While having pointed out the obvious value of the Butterfly gap road for non-mineral exploration and mining purposes, several actions can be taken to make the road more attractive and to cause it to better blend into the background. The road sides can be smoothed out and re-seeded. The drill pads can be converted into "turnarounds," and re-seeded. While it is unlikely that the Butterfly gap road will ever be used for its originally intended purpose, it is extremely valuable as an access road to an otherwise inaccessible portion of the Mammoth mine center property. By re-seeding and smoothing out the rough places, it can be made to look more attractive. This we are committed to do.

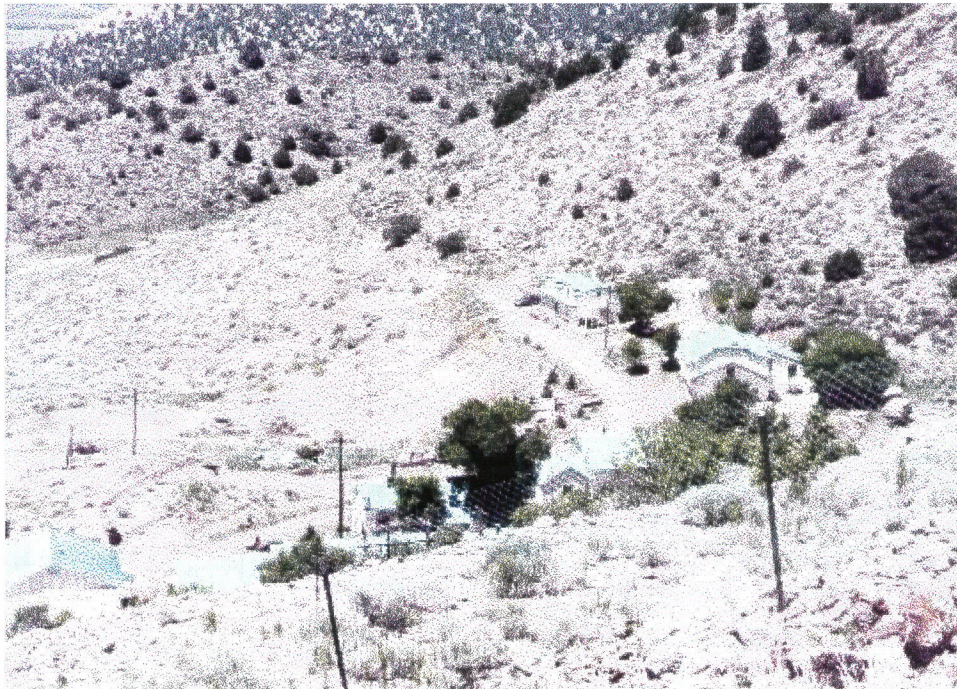
The Mammoth mine area is located at the eastern end of Mammoth gulch. This locality has been converted from its originally mining related purpose to the center of a real estate/historical development project. Six of the old mining buildings have been restored and converted to non-mining uses. An effort has been made to leave enough of the old mining sites intact so that the historical flavor can be preserved. None of the Mammoth mine center buildings are suited for any mining related purpose in the industrial setting of the modern mining industry. The transition has been somewhat slow (because of financial limitations) but steady. The Mammoth mine center now includes the mine dumps, mining ruins (not yet restored), business offices, storage facilities and residential areas. Included at the Mammoth mine center are several key historical points of interest including the restored McIntyre Mansion (built about 1895), the old Mammoth mine office, the upper shaft house (still not restored), and a graveyard of historical mining equipment. Keystone et al have been working to do cleanup and fix-up, but with the goal not to destroy the historic appeal of one of the last working mines carried over from the 19th Century. We have completed the dismantling and removal of the antique ore chute (a danger to the public), restoration of and conversion of various antique mine buildings into historical and museum sites, or residential and business offices. We are still working on cleanup and the removal of sampling bags, drill core and trash. Waste rock dumps are located on the northern and western edges of the Mammoth Mine area. Further reclamation and restoration planned includes further cleanup of the surrounding Mammoth mine center and surrounding area, consistent with maintaining its 19th century mining flavor. I do not contemplate further mining or exploration work at Mammoth in my lifetime!!

The Mammoth area, looking west from the Gulf Stope. (205-22)

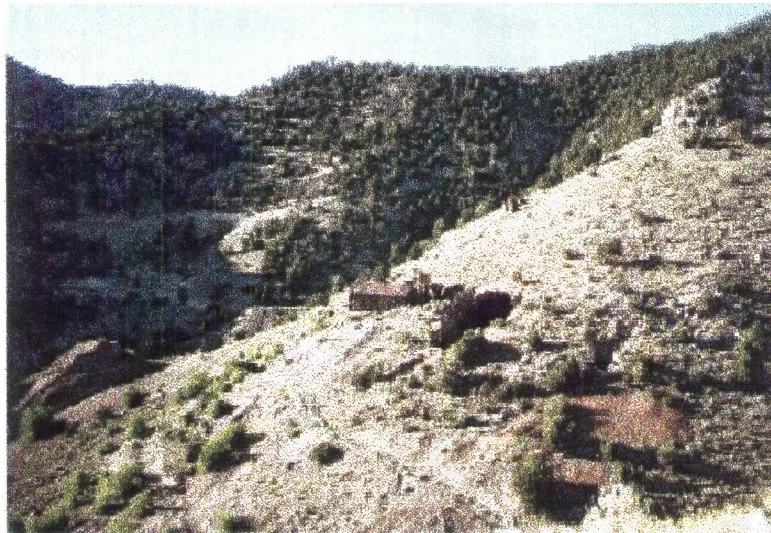
The Mammoth copper oxide adit is located immediately south of the Mammoth glory hole, and within the fenced perimeter. The area around the adit has been naturally revegetated by nature and extensive growth of brush, trees, and various grasses are present. The adit is currently boarded up and secured from access. No reclamation here is needed or appropriate other than making certain the existing fence remains intact. Refer to section 9 for the photo.

The road above the plummer tunnel will be left open and maintained to allow access to the water tanks currently used to provide water to the Mammoth mine site for all purposes. It is also the access road to maintain the Mammoth glory hole fence and for possible fire control purposes. Since this road will need to stay open to access water tanks, fire control purposes, and access the Mammoth glory hole fence, reclamation is not appropriate. This road occupies an estimates .15 acres.

This photo shows the copper oxide adit as well as the road above the plummer tunnel. The adit is to the right of the Gulf Stope. (204-13)

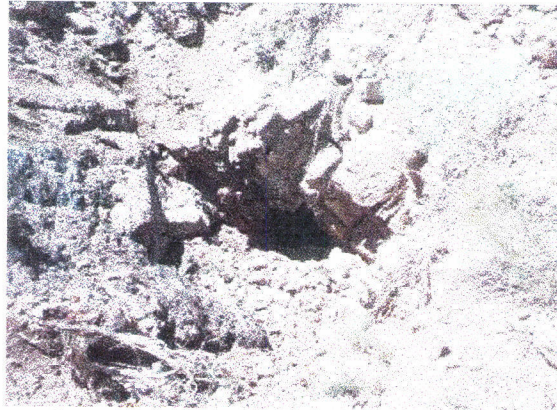
The Mammoth Hole-In-The-Wall adit is located between the shaft house and the water tanks. It connects with the Mammoth shaft at the 200 ft. level. The opening is approximately 1 ft. x 2 ft. and is partially collapsed. The area is heavily vegetated with heavy brush, trees, and various grasses. There has been no post 1974 law activity. There is considerable waste rock adjoining the adit. This waste rock originated from several locations including Hole-In-The-Wall adit and the Gulf Stope. Post 1974 law consisted only of geologic sampling and inspection. Although the adit adds historical perspective

The Hole in the wall adit. Note the partial collapsing and the vegetation (205-21)

to the Mammoth mine site area, it could be dangerous and should be fenced or otherwise closed.

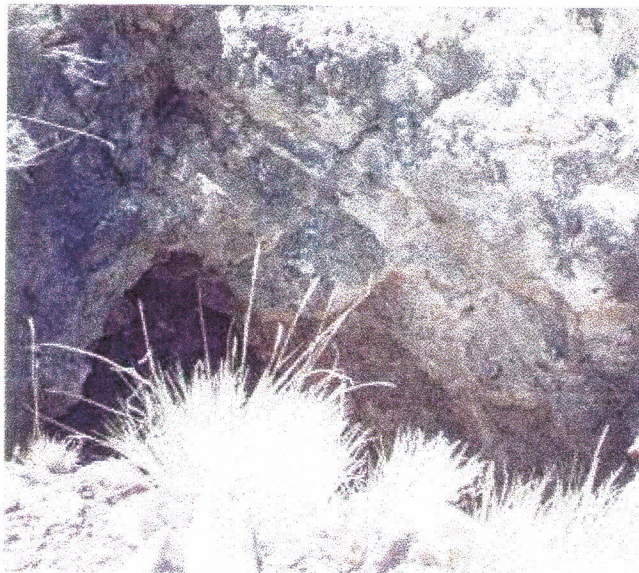
The Mammoth Finn tunnel is located approximately 600 ft. southeast from the Mammoth shaft. The Finn tunnel is driven northwest into competent rock and its portal measures 1 ft. x 2 ft. The only access to this tunnel is through the Mammoth mine site, two locked gates and a 24 hour watchman. The last work in the area was probably 100 or more years ago, and the area is well naturally vegetated. The tunnel is not visible through the vegetation. There is no evidence of waste rock or other waste in the area. The tunnel has experienced no post 1974 law disturbances. No reclamation is appropriate.

Mammoth Finn tunnel and surrounding vegetation (204-9)

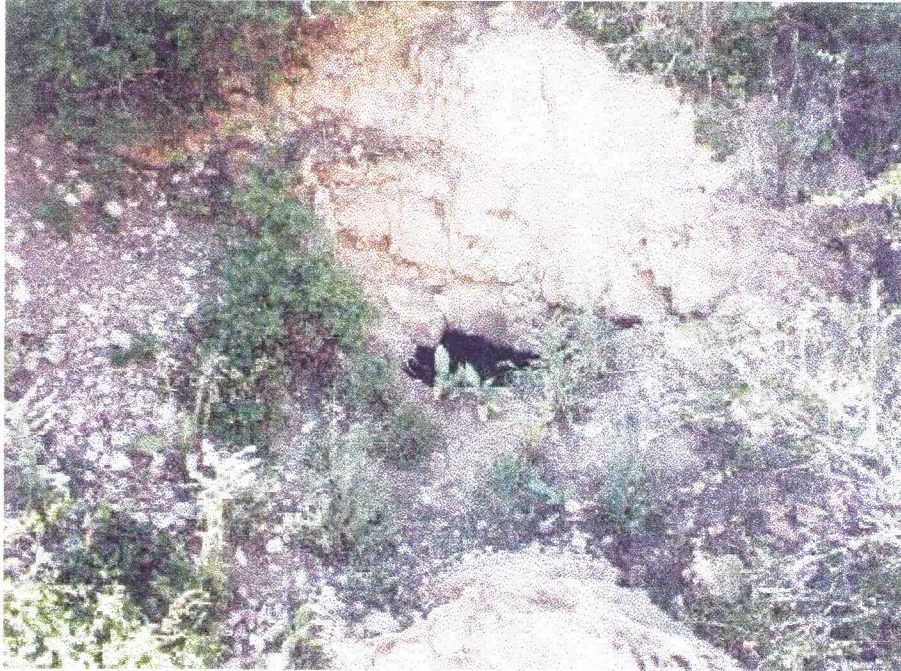
The Mammoth Hungarian tunnel is located 200 ft. northwest of the Mammoth shaft. The tunnel is driven south into competent rock and its present portal measures approximately 4 ft. x 3 ft. The waste rock dump is minimal, covering an area less than 10 ft. in diameter. This area has experienced no post 1974 law disturbance. The last work was probably 100 or more years ago and the area is well naturally vegetated. The access is restricted by two locked gates and a 24 hour watchman. The tunnel does not constitute a danger and no reclamation is appropriate.

Mammoth Hungarian tunnel, note the vegetation growth at the entrance. (202-19)

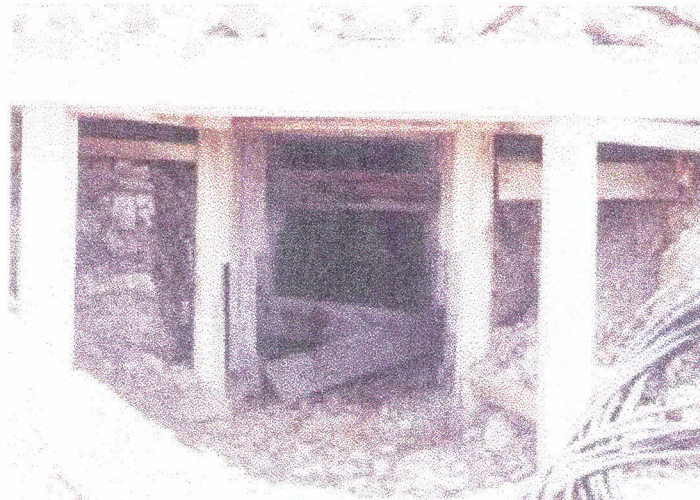
The Plummer tunnel is located 150 ft. downhill and to the southwest from the Mammoth shaft. The Plummer tunnel is driven easterly into competent rock and its portal measures 6 ft. x 6 ft.. Currently the entrance to the tunnel is timbered and open. The area is moderately vegetated with heavy brush, trees, and various grasses. The ore shoot below the tunnel was recently dismantled and removed from the site. The tunnel was opened about 1993 by Centurion Mines Corporation and a new portal was installed and new timbers (where needed) inside the tunnel. An unsuccessful effort was made by Centurion

to obtain commercial production from an oxidized copper ore body accessed by this tunnel. There is some roadway and access disturbance adjacent to the tunnel, and the portal is currently accessible. Again, the area is protected from public access by two locked gates and a 24 hour watchman. The portal should be sealed with timber or using a combination of timber and chain linked fencing. Some reseeding of the portal area and access roadway should be carried out.

The entrance to the Plummer tunnel (199-2)

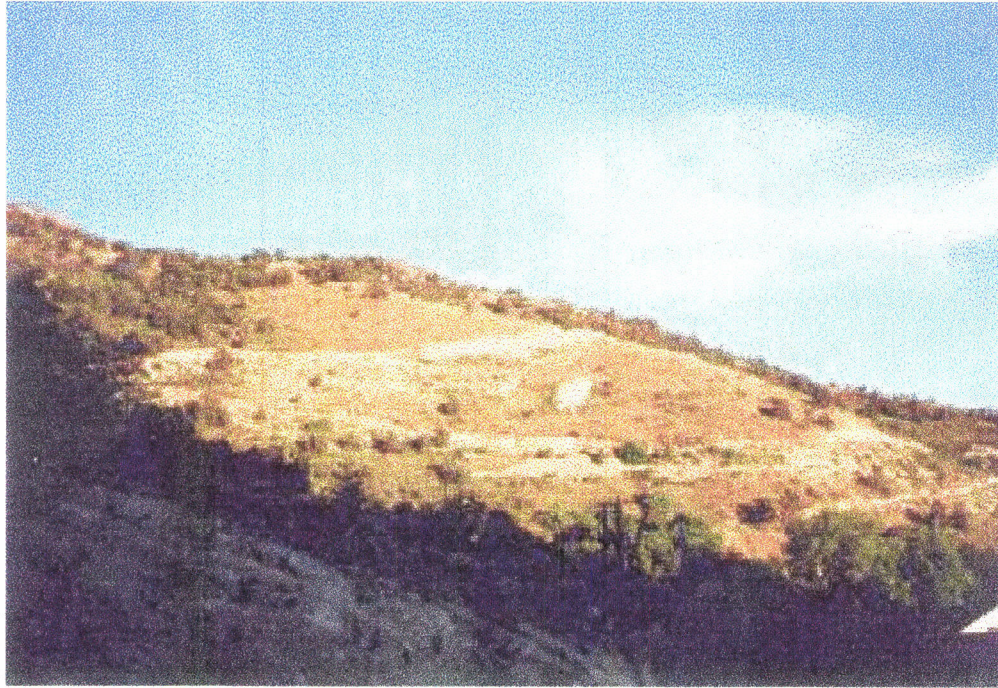
The Nad Breccia road is located 300 ft. southeast from the McIntyre mansion. The original road, which accesses the Phoenix claim area, was constructed at least 100 years ago using horses and scrapers. During 1993 the then existing Nad Breccia road was widened and improved (post 1974 law). Keystone plans to keep the road in service as access to panoramic tourist view sites that overlook the historic Emerald, Opex, and Grand Central mine areas, and across the town of Mammoth, the Tintic Valley and the West Tintic Mountains. This road provides access to possible future residential sites. The post 1974 law disturbance consists of widening and improving the road that was previously existing. The estimated disturbance is 1.0 acre. This road is entirely on privately owned land. Since this road is imperative to the growth of Mammoth, we urgently request that it remain open for non-mining purposes. Reclamation consisting of reseeding the road edges, cleanup of loose rocks and trimming natural overgrowth can be done.

The scenic Nad Breccia Road. (204-23)

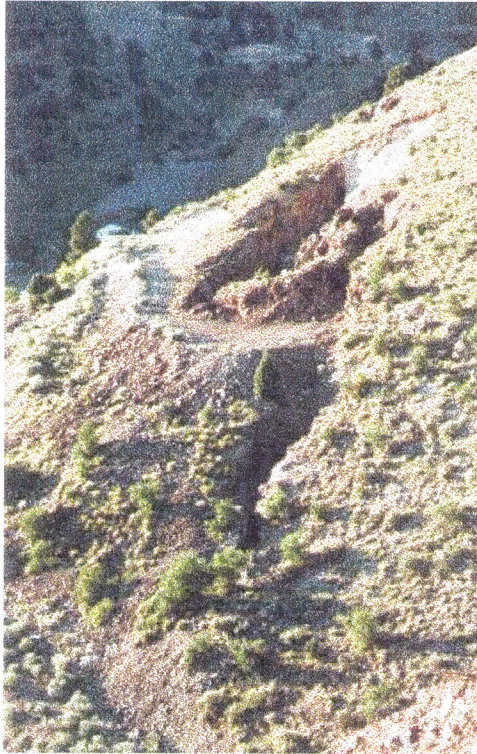
The Ajax Mine adit and drill pad are located approximately 800 ft. southerly from the Mammoth mine center. The adit is adjacent to the drill pad. The area is moderately vegetated with several species of grass, tree, and brush. The Ajax mine adit portal is approximately 5 ft. x 20 ft. and driven into competent rock. The portal is experiencing moderate amount of caving, mostly of unconsolidated earth material at the portal. The waste rock dumps in this area are considerable in size and mix with dumps from various other mines including the Gold Chain. These mine waste rock dumps originated from mine development work performed prior to 1930. Except for the construction of the drill pad and setting timbers inside the mine adit, no post 1974 work has been performed. Keystone commits to completing the reclamation already mostly performed by Centurion. Keystone will complete reseeding of the drill pad and reinforce the closure of the Ajax mine adit.

The Ajax mine adit and drill pad, looking north.

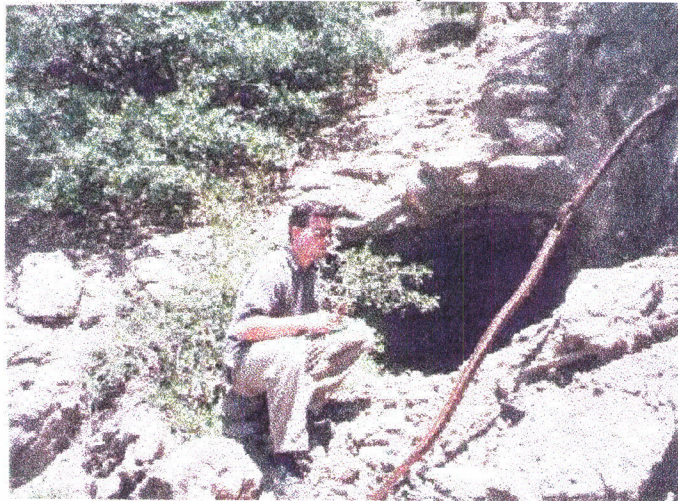
The Gold Chain tunnel is located approximately 800 ft. north from the Ajax shaft (see map). The tunnel is driven northerly into competent rock and the portal measures 4ft x 4ft., and is open. The mine portal shows very little caving. The area is naturally vegetated with heavy brush and various grasses. The waste rock dumps for the tunnel mix with the Ajax workings. There has been no post 1974 law disturbance at this site. A fence or other barrier should be constructed to deny access to the tunnel.

Gold Chain tunnel and surrounding vegetation. (205-21)

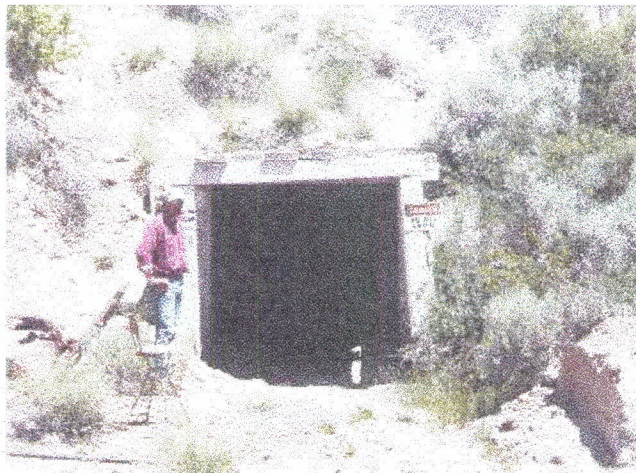
The Sioux-Ajax tunnel is located approximately 500 ft. southerly from the McIntyre mansion. The Sioux-Ajax tunnel is driven easterly into competent rock and its portal measures approximately 6 ft. x 5 ft. Currently the Sioux-Ajax tunnel is sealed with a locked modern timber gate, about 15 ft. inside the portal, which denies access. The timbered frame at the portal is in good condition. The area near the portal shows no caving and the entrance is in good condition. Moderate natural vegetation surrounds the area and includes various natural grasses and brush. The waste rock mine dumps from the tunnel are mixed with material from other mines including the Gold Chain and the Ajax. There has been no post 1974 law activity at this site except the retimbering inside the tunnel to permit underground sampling for mining exploration. This work was carried out by Centurion Mines Corporation, the predecessors to Keystone in ownership. Reclamation for this site has been completed.

The Sioux-Ajax tunnel, not visible because of the heavy shadow is the timbered gate. (205-10)

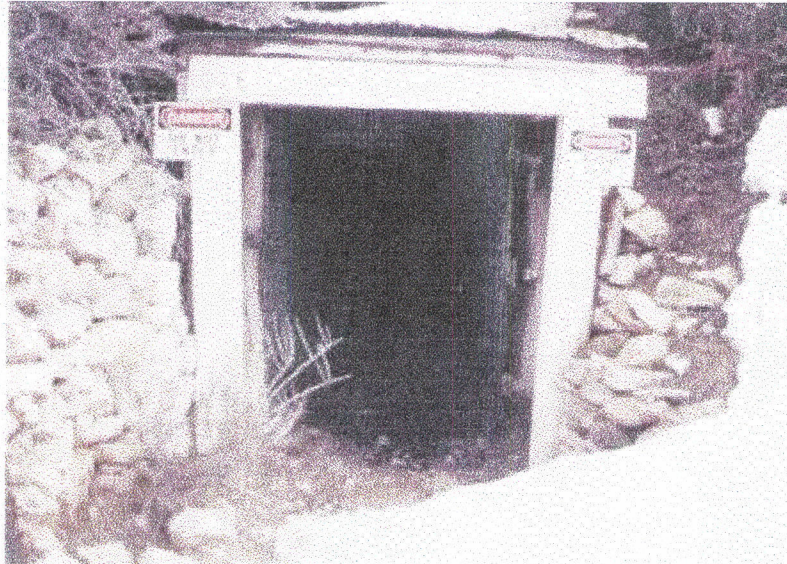
The Lower Mammoth tunnel is located approximately 1000 ft. west of the Ajax shaft, and downhill to the west from the Sioux Ajax tunnel. The lower Mammoth tunnel (which is really a mine shaft access adit) is driven south-southeasterly in competent rock to provide access to the underground Lower Mammoth underground shaft. The adit portal is 5 ft. x 5 ft. The area surrounding the tunnel is naturally vegetated with trees, brush and various grasses. The waste rock dumps are located downhill (westerly) from the portal. The Lower Mammoth tunnel is currently sealed with a locked steel grated gate. There has been no post 1974 law surface disturbances. However, Centurion reconstructed the adit portal in 1993 and new timbers were set inside the adit to permit safe entrance. A new

portal was constructed and the present secure steel gate was installed. There was no removal of waste rock from the adit. Reclamation at this site is complete.

Lower Mammoth tunnel showing shadowed view of steel gate. (199-15)

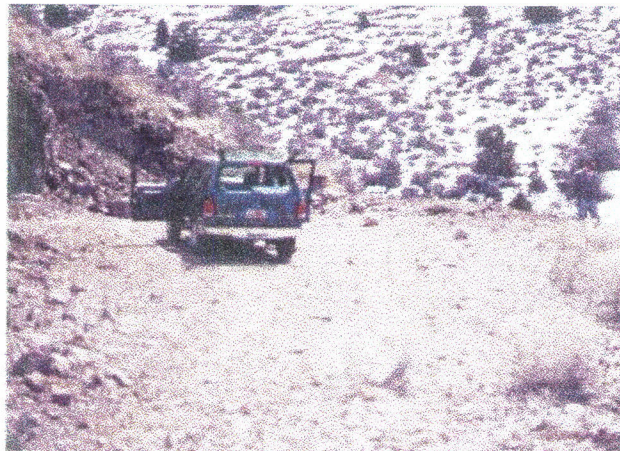
The Nad Breccia drill pad is located near the end of the Nad Breccia road, and about 1500 feet southeasterly from the McIntyre mansion. This pad has become part of the road itself and provides a very useful “turnaround.” This pad was constructed about 1993 and is partly reclaimed. Additional “smoothing” of the pad margins, and reseeding the portions of the pad that are not in use as a “turnaround” could be done. The pad needs to remain generally as it now exists for use as a part of the access road to the area. post 1974 law and is currently being used. Keystone will perform these reclamation tasks.

Nad Breccia Drill Pad and surrounding area. (199-26)

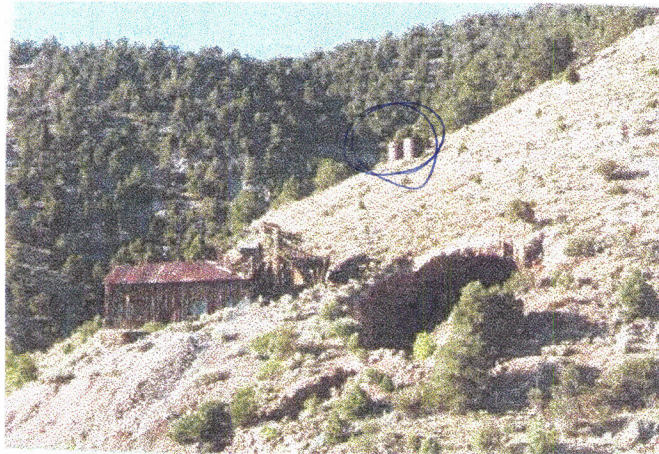
The historical Mammoth water tanks are located both 50 ft. above the shaft house and 150 ft. below. These tanks served the mine operations somewhere around the turn of the last century. These tanks are badly corroded and serve no purpose except to add to the historic Mammoth mine center experience. They are in stable condition and pose no danger. Keystone would like these old water tanks to remain where they are as

memorabilia from days long gone. No reclamation is required. It appears to me that these tanks have remained in their present position for at least a century.

Mammoth Water tanks

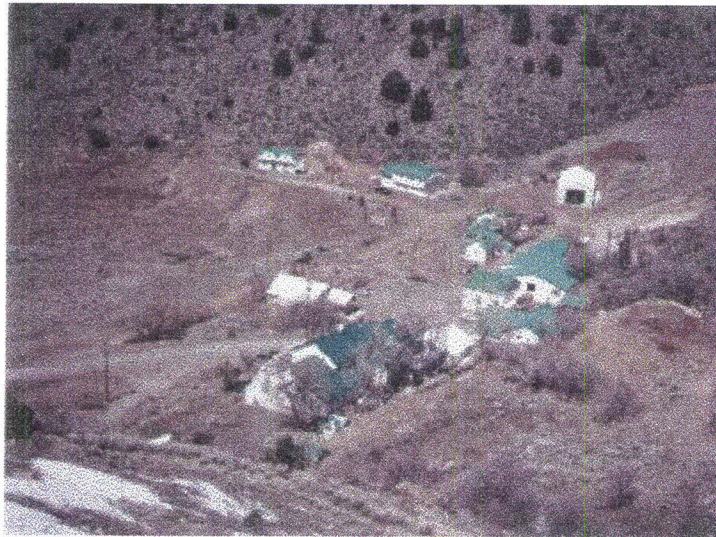
The Mammoth lower tunnel road and ore piles are located west from the Mammoth Mine site. This road was constructed at least 50 years ago and is currently being used as an alternate access to the residence and business offices at the Mammoth mine center site. The road is maintained and in good condition. The ore piles date from the active mining period at the Mammoth mine, which is probably prior to 1930. None of the ore piles and disturbance is post 1974. Since this road is currently being used and maintained and the mining dumps are old, no reclamation is necessary.

Picture showing ore piles west, north, and east of the Mammoth Mine site

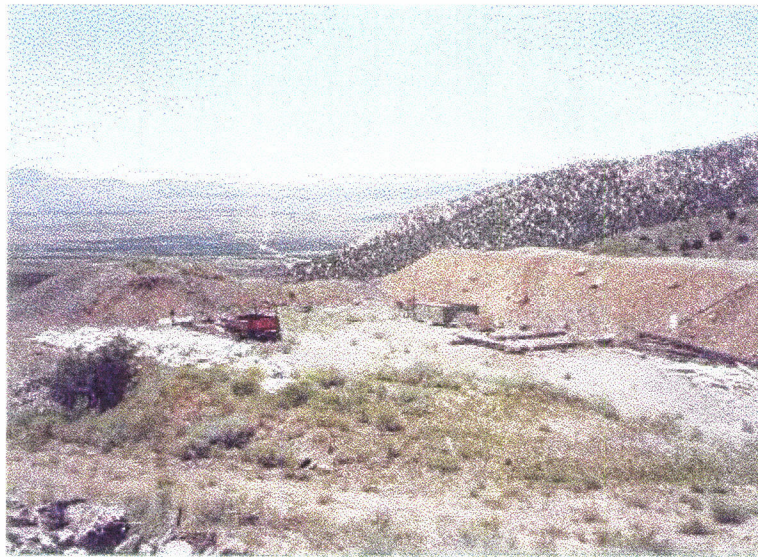
The Mammoth mine storage area is located about 750 ft. southwest of the Mammoth Mine site and was constructed in 1993 to be an “out of sight” location for storing various antique mining related items that might have use in the future, and therefore should not be discarded. This storage area is surrounded by waste rock dumps from the Gold Chain and Ajax mines which obstruct visibility from the access road. It was constructed as a storage pad and occupies about .25 acres, and is out of sight except to those who walk or drive right up to it. There is some drill core and sample cuttings piled neatly there on the ground. Old equipment stored there includes a diamond drilling mud mixing tank, timbers, rails, and drilling rods. Everybody needs a storage yard for such things that are not in current use and should not be discarded. Current reclamation plans include making the area neat, partial reseeding, and the removal of those samples in bags that are from drilling on properties no longer owned by Keystone or Mammoth Mining Company. No other reclamation is planned or deemed appropriate at this site.

Picture showing Mammoth mine storage area
